DETAILED UXO RISK ASSESSMENT

STAGE 2 DETAILED UXO RISK ASSESSMENT

Client:	TEC Ltd		
Project Ref:	TWEE89R		
Site:	Project Dragon, Port Talbot		
Report Ref:	DRA-23-1532-TWEE89R-ProjectDragon,PortTalbot		
Revision:	1		
Status:	Final		
Release Date:	19 th April 2023		
Written By:	Alfie Hanford	Project Researcher	alfie.hanford@brimstoneuxo.com
Reviewed By:	Harry Smith	Senior Project Researcher	harry.smith@brimstoneuxo.com
Authorised By:	Aaron Florence	Managing Director

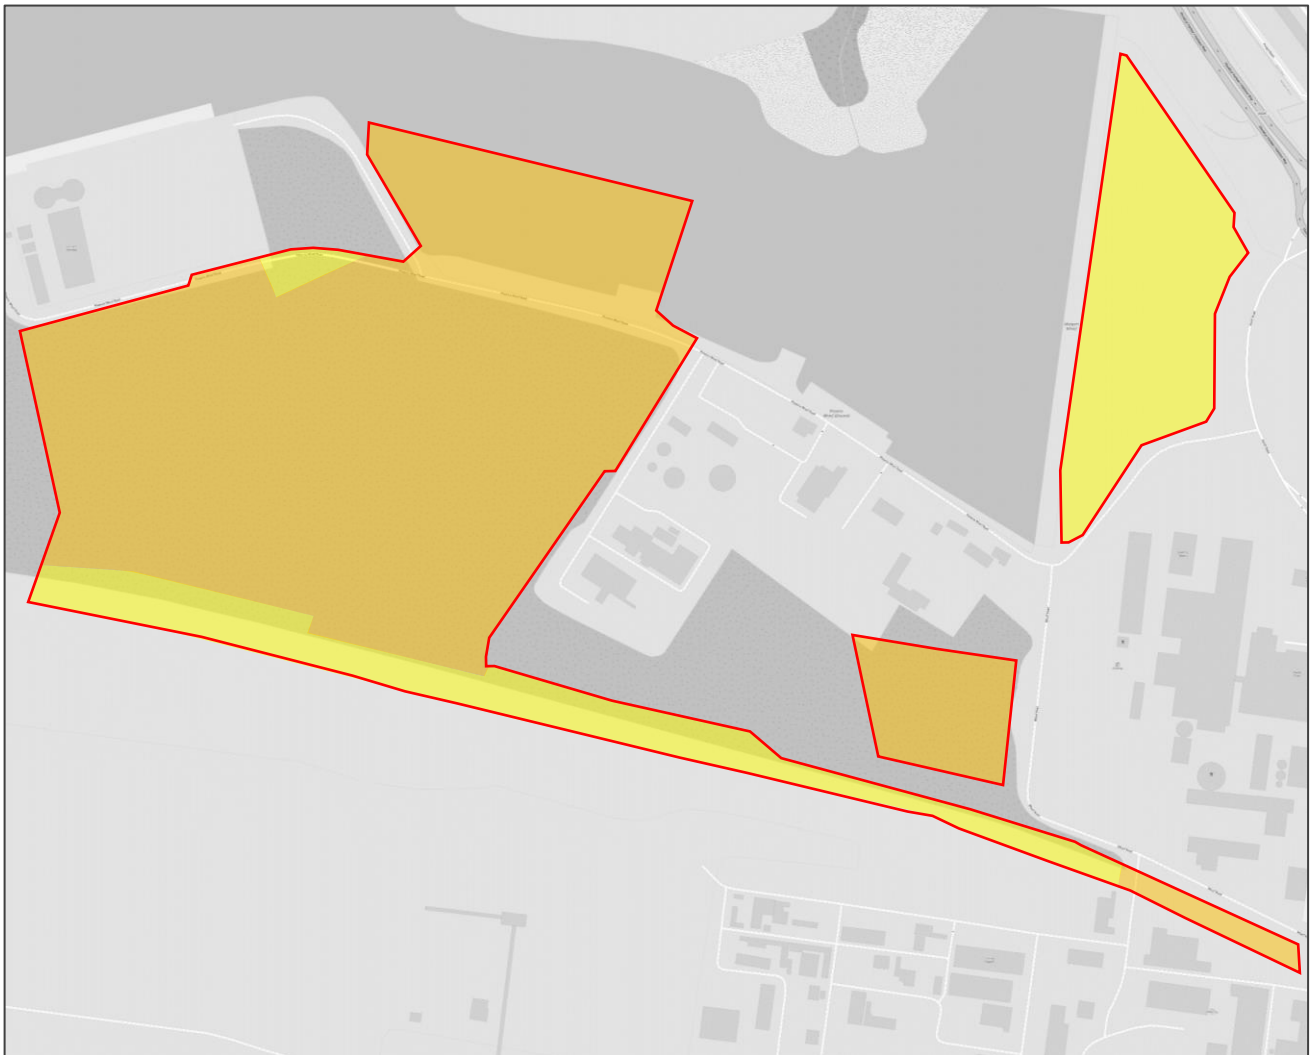
Risk Map:

RESULT: Brimstone concludes that German UXBs and unexploded HAA shells poses a **LOW-MODERATE AND MODERATE RISK** to the proposed works. See **FIGURE 7** for risk mapping.

Low-Moderate Risk from German UXBs & HAA Shells

Moderate Risk from German UXBs & HAA Shells

RECOMMENDED RISK MITIGATION MEASURES: The measures detailed below are recommended to mitigate the risk to ALARP level.

Risk Mitigation Measure	Recommendation
UXO Safety Awareness Briefings	Prior to all intrusive works commencing.
Non-Intrusive Magnetometer Probe Survey	Open excavations on greenfield land within the Moderate Risk zone.
Intrusive Magnetometer Probe Survey	Of all pile positions within the Moderate Risk zone.
EOD Engineer - On Site Supervision	Watching brief of all open excavations and magnetometer survey of all borehole locations within the Moderate Risk zone.
