ABP Port Centric Survey Report

APLS-1174 Harbourside Port Talbot
Survey Control & Topographic Survey

**APLS-1174 Harbourside Port Talbot
Survey Control & Topographic Survey
Survey Report**

**Project Dragon – Sustainable Aviation Fuel
(SAF) Production Facility: Production
Development Zone (PDZ)**

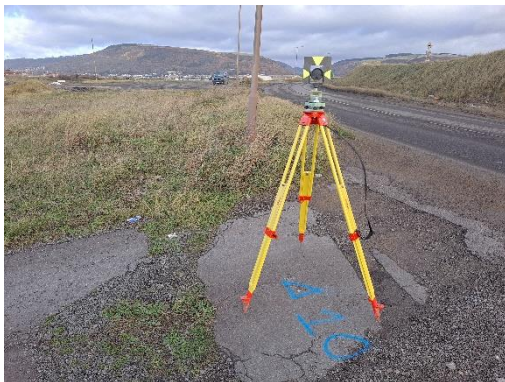
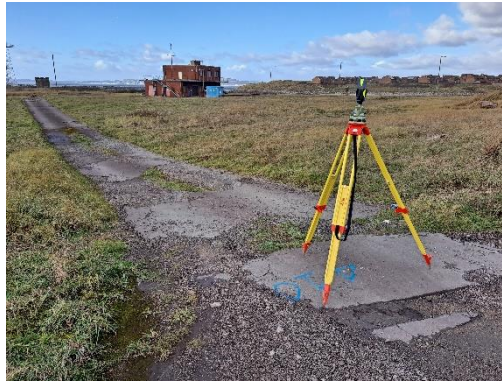
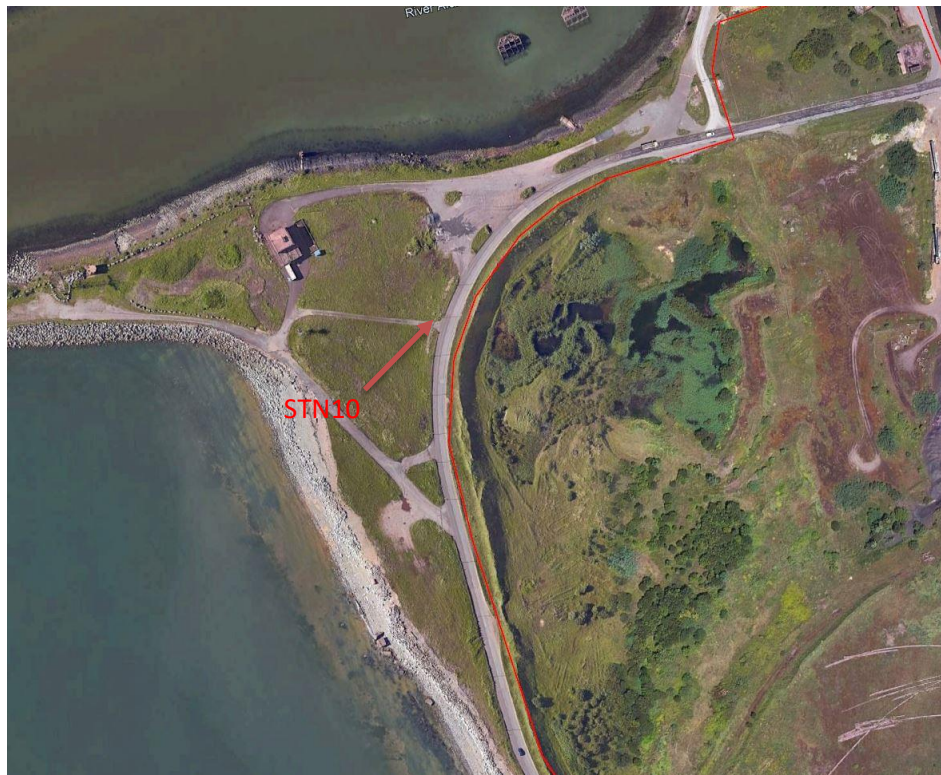
APB Port Centric – Port Talbot Installed Control Stations

Station ID : STN10
Easting : 275344.430
Northing : 188557.341
Elevation : 9.124mAOD
Description : MAG nail & washer installed in tarmac access road.
Photos:

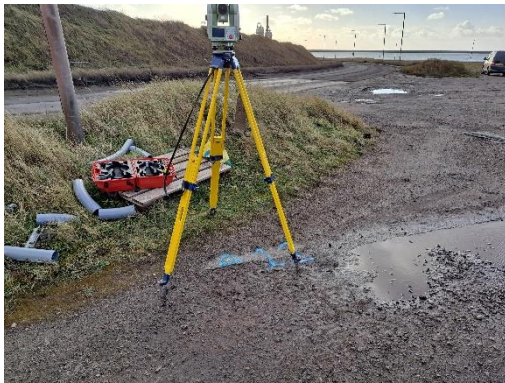
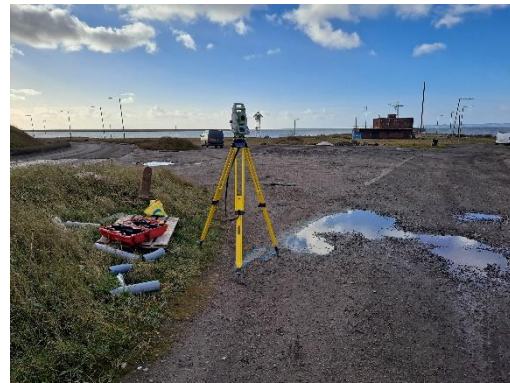
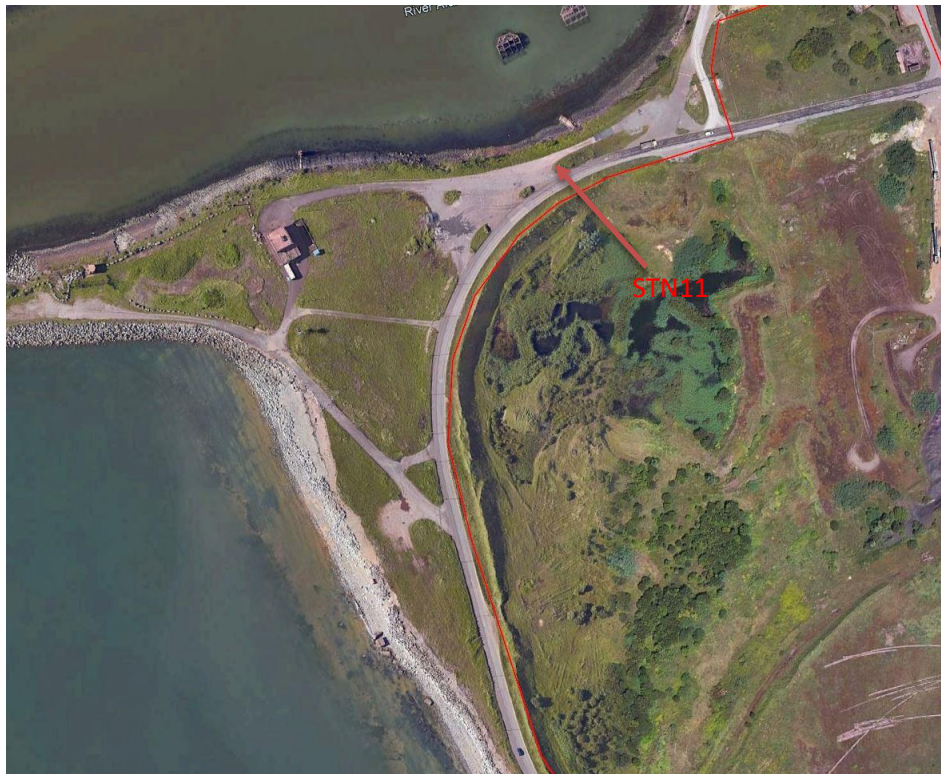
Installed Control Stations

Station ID : STN11
Easting : 275398.920
Northing : 188635.081
Elevation : 10.647mAOD
Description : MAG nail & washer installed in tarmac access road

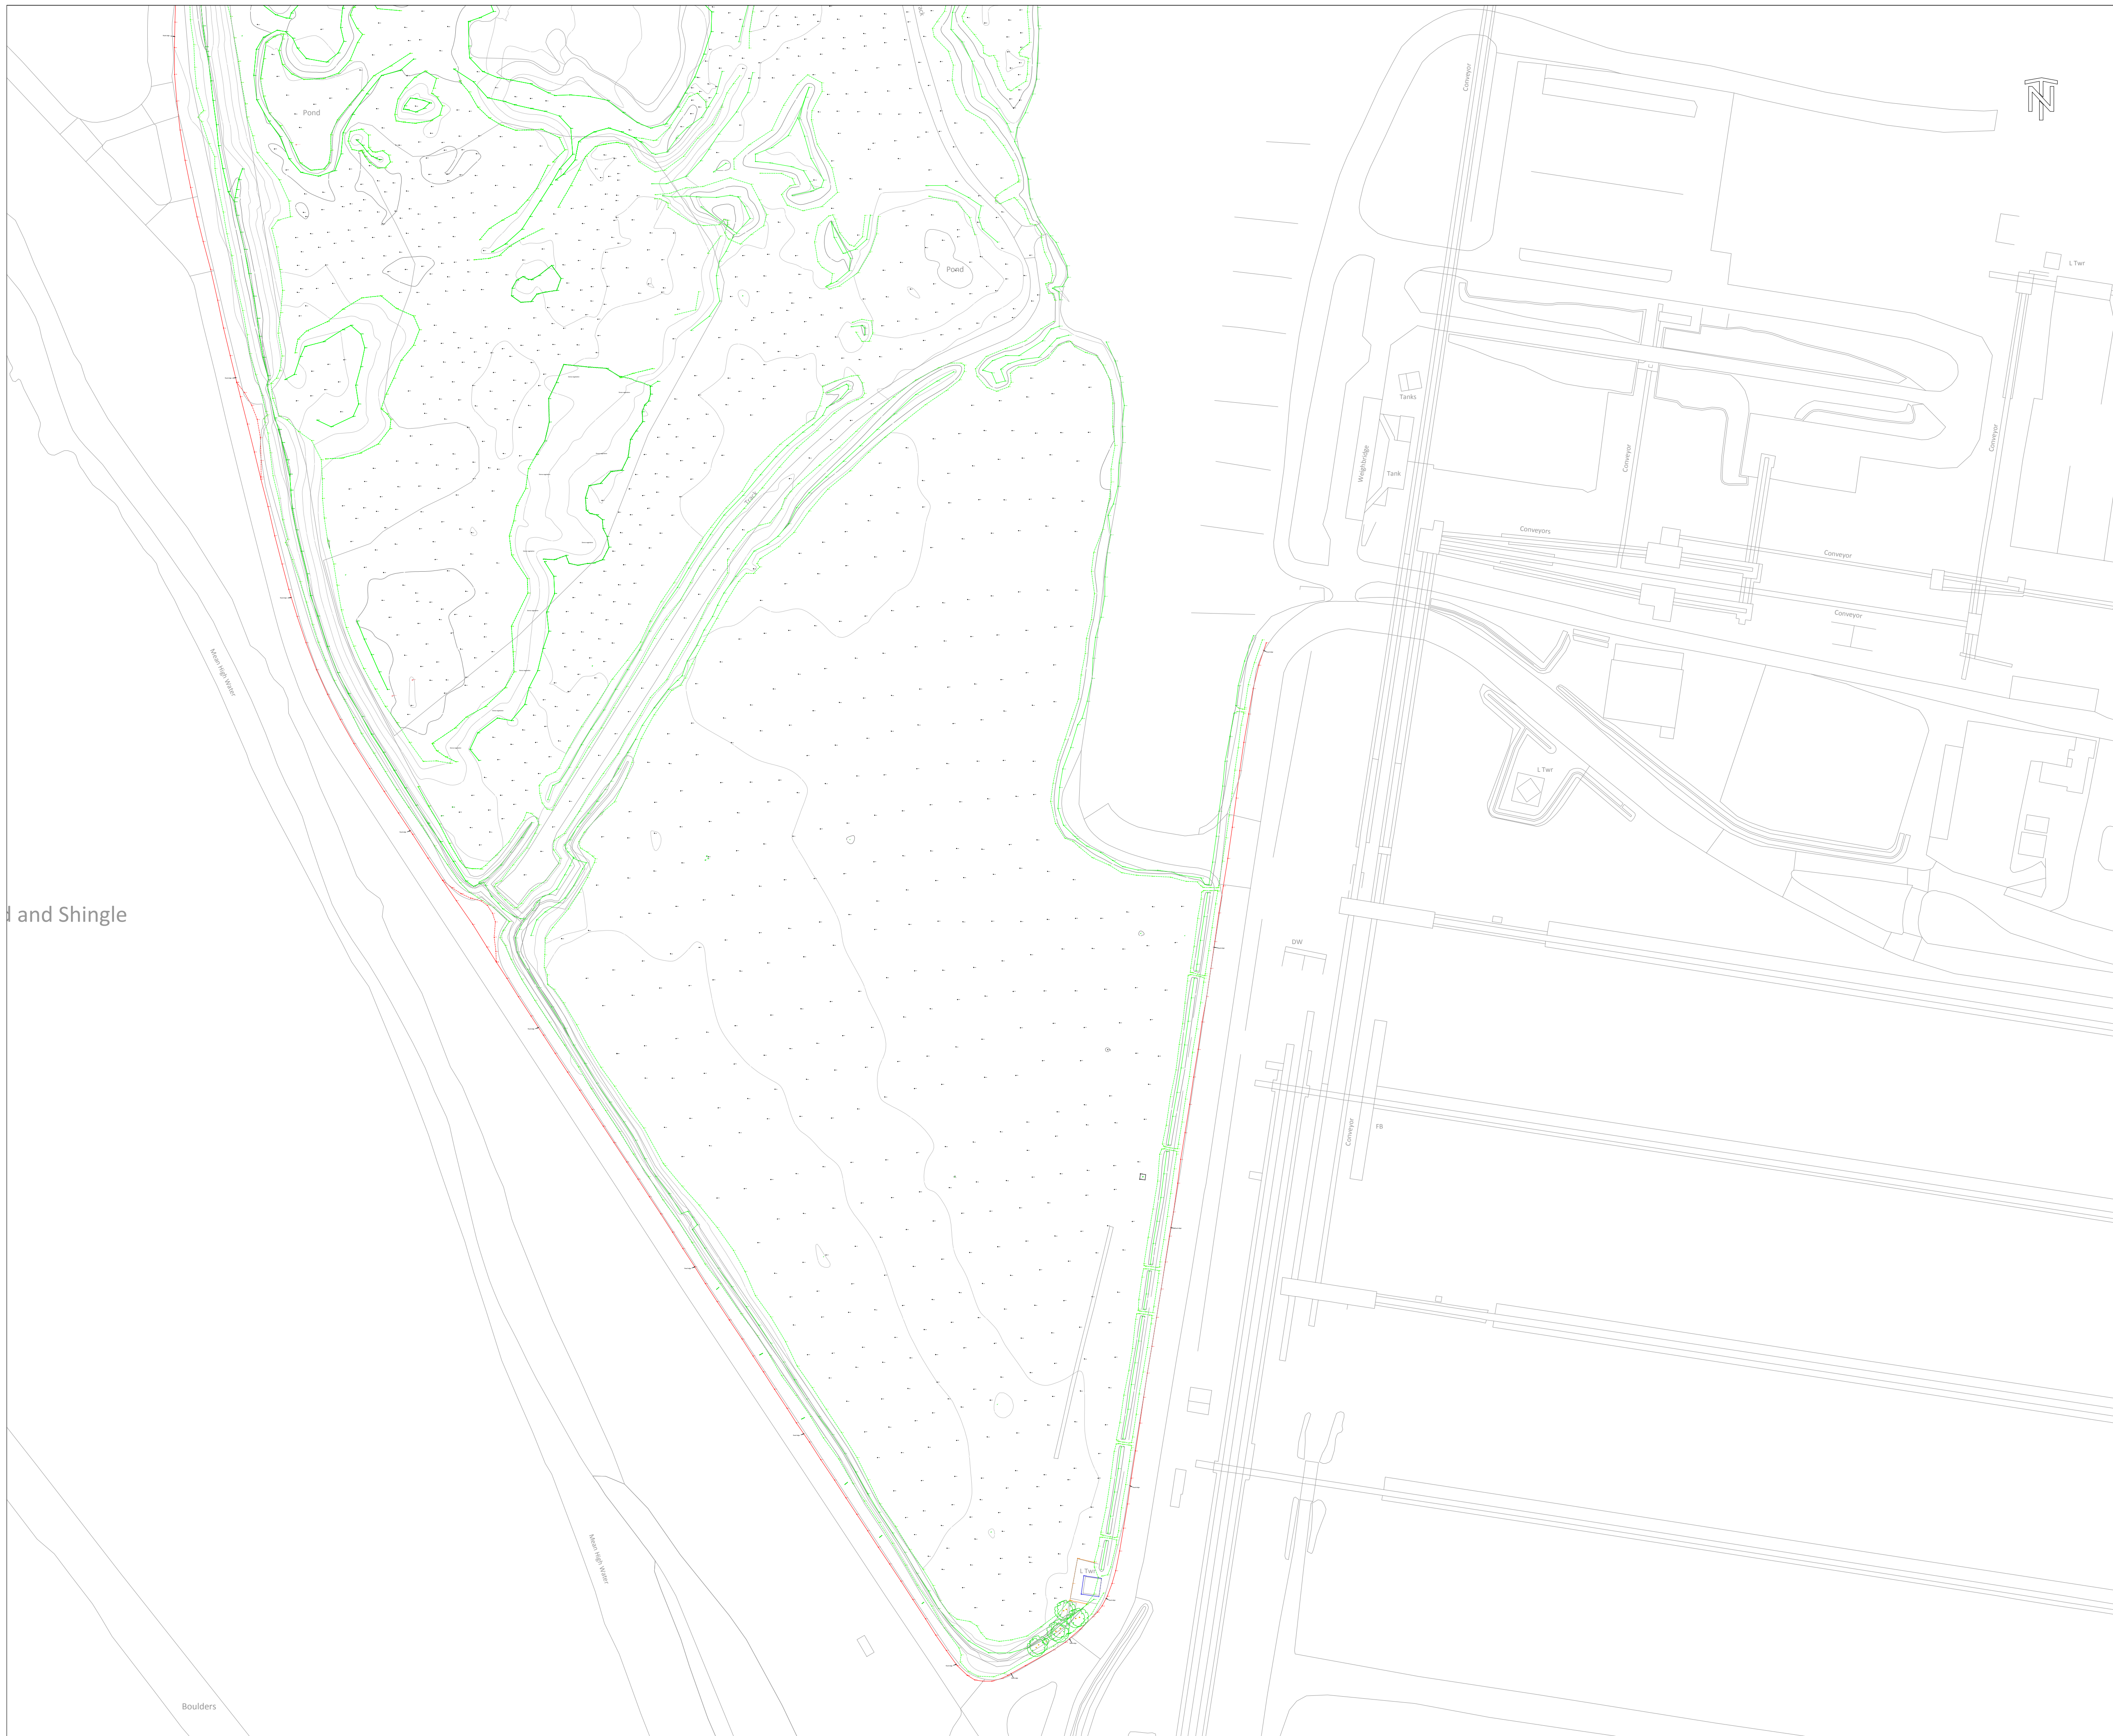
STATIONS ESTABLISHED:
 NAME CO-ORDINATES LEVEL
 STN10 275344.430E 188557.341N 9.124m AOD
 STN11 275398.920E 188635.081N 10.647m AOD

SURVEYED BY: AP Land Surveys		Ref: APLS-1174	
SURVEY DATE: DECEMBER 2021			
SCALE: 1:1,000@A1	DRN: AMP	CHKD: AJP	
DATUM: ODN	DATE: DEC 21	DATE: DEC 21	
GRID: NATIONAL	DRAWING NO. APLS-1174-002	REV: -

APLS-1174-001 to 005 – Site topography

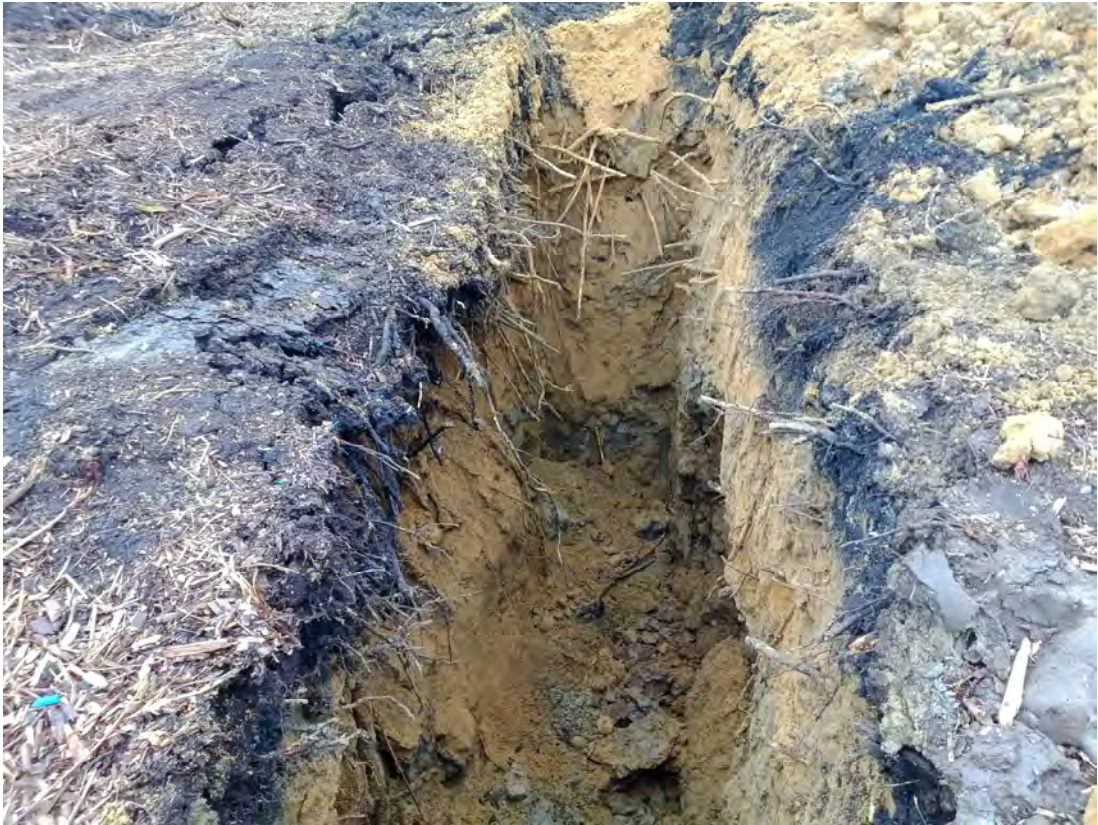
Photograph 1: Excavation at TP03.

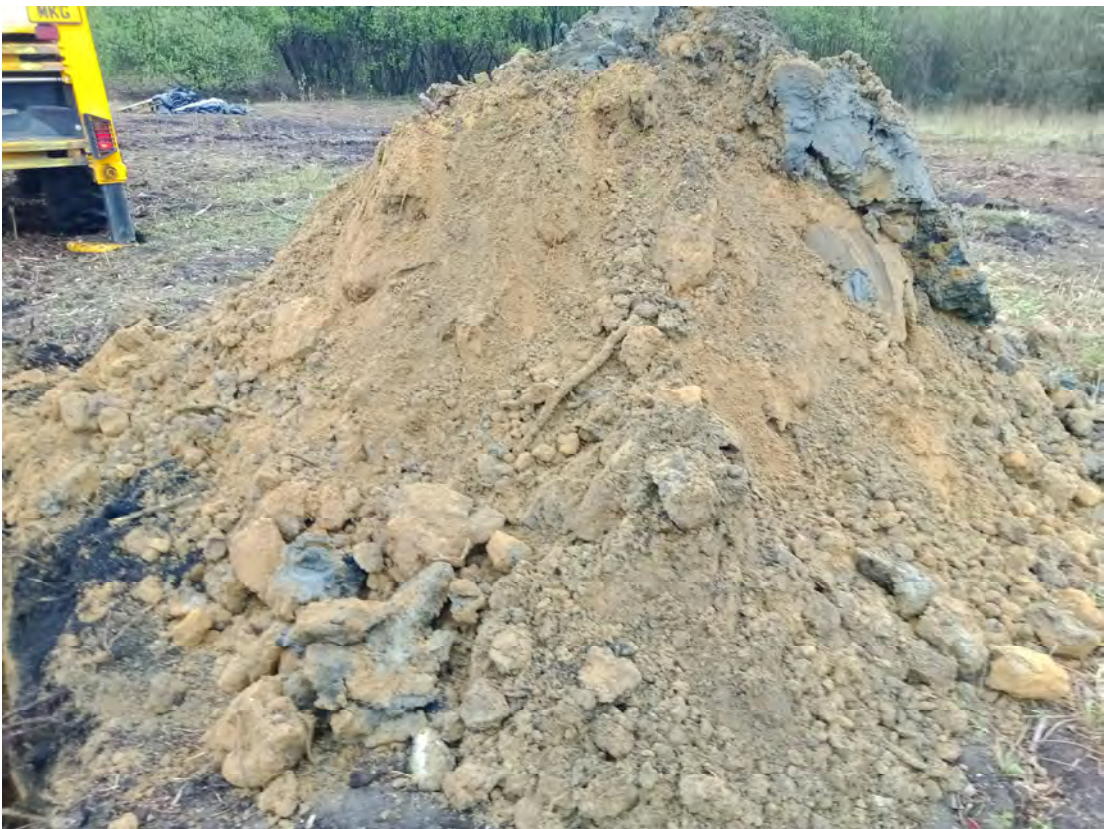
Photograph 2: Excavated materials from TP03.

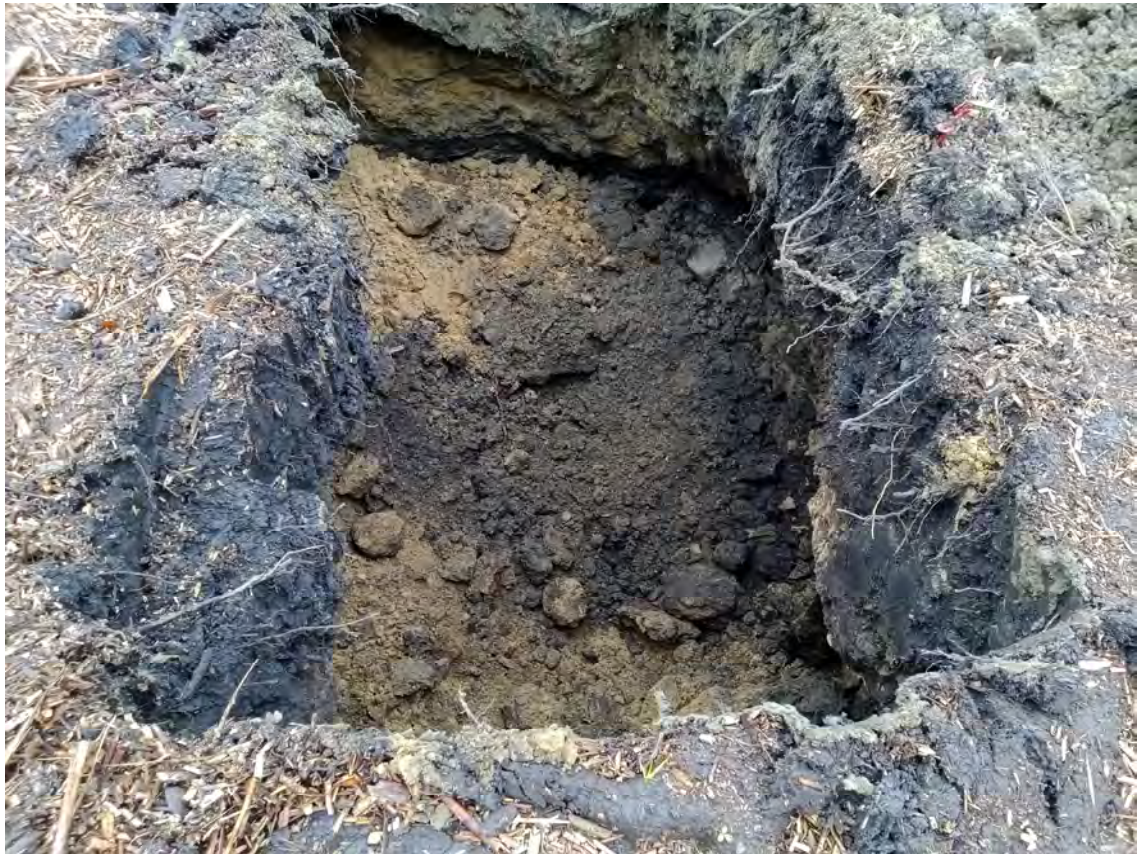
Photograph 3: Excavation at TP05.

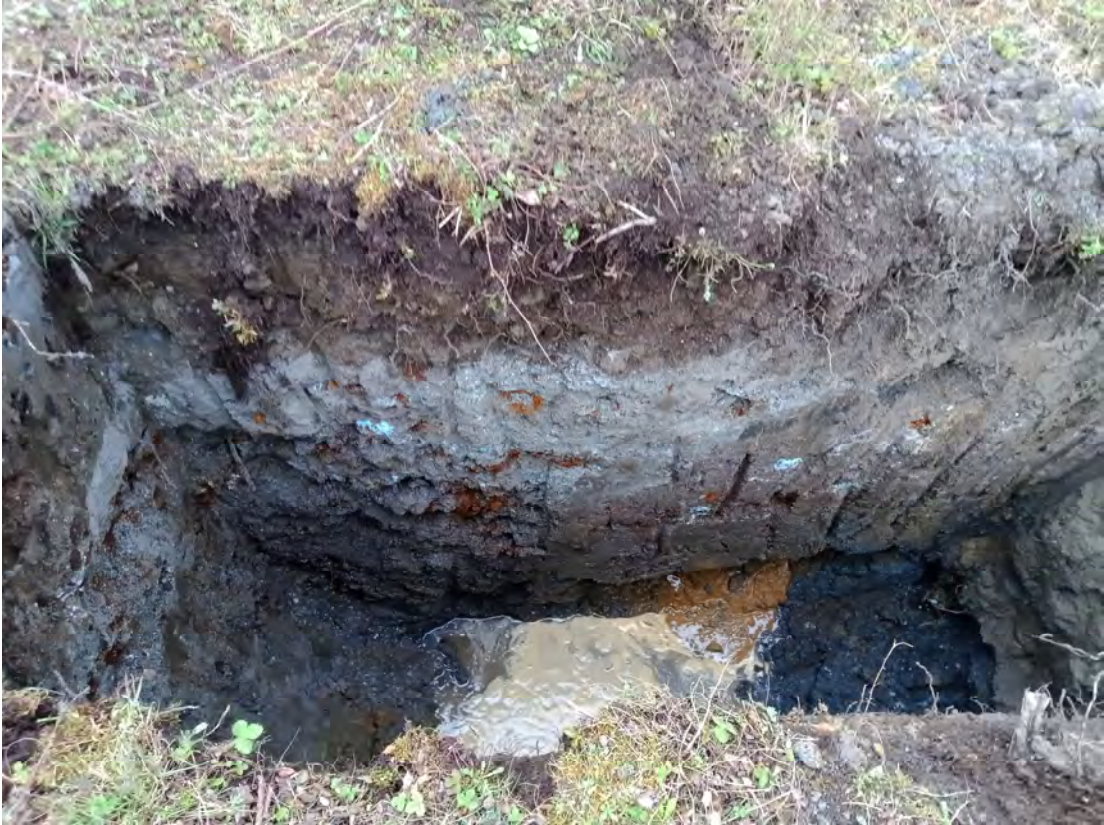
Photograph 5: Excavation at TP12.

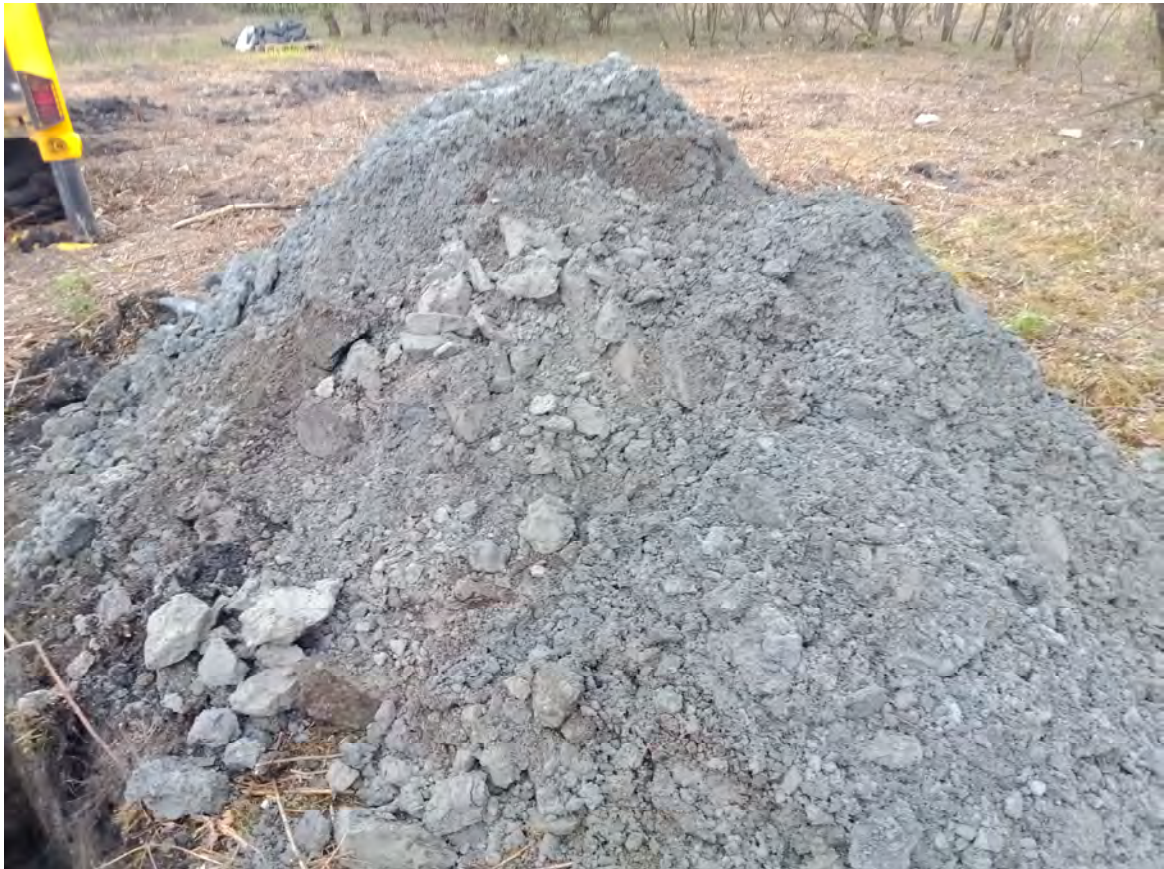
Photograph 6: Excavated materials from TP13.
